Repairing switch holding nut (Rabbit-3,-6, Woodpecker, Stonechat)

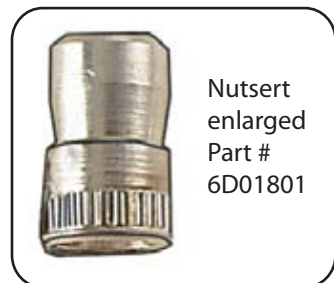
Step 1.
 Identify the problem.
 If the nutsert is stripped in the tube then...
